FINAL: Power 2014-32208

MAINTAINING HIGH ENERGY PIPING INTEGRITY WITH UNIT SPECIFIC STRATEGIC PLANNING

Pamela Hamblin-Smoske
Director of Development and Operations
Thielsch Engineering, Inc.
Cranston, Rhode Island, USA

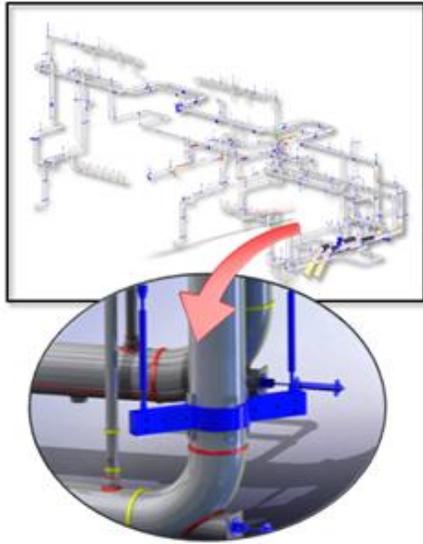
Figure 1. Typical hanger design and location.

Hot and Cold condition walkdowns of the hanger supports in each system should be audited annually. This will ensure that the piping systems are supporting as predicted and intended by the designer. (The condition of the supports provides an accurate

barometer of the overall condition of the applicable high-energy piping system. This is supported by the fact that over 95% of the through wall failures reported in high-energy piping systems is related to applied bending stresses from external or off design conditions. Often times these stresses are the result of improperly designed or malfunctioning hanger supports.) Figure 1 below illustrates a typical hanger design and location.

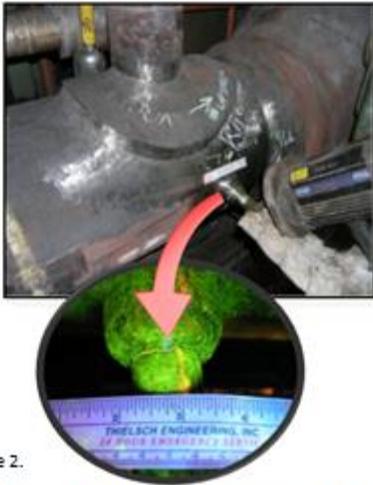
Figure 2.
Example of a surface indication discovered during a routine outage inspection.

In some instances, the responsibility can be related to a combination of several of these classifications. For example, a pipe weld containing root defects, such as lack of penetration, may not fail during service until thermal or mechanical fatigue of sufficient magnitude initiates cracking and crack propagation of the existing defect through the cross sectional thickness. Figure 2 below illustrates a typical surface indication which required repair welding. The indication was discovered during a routine scheduled outage inspection.

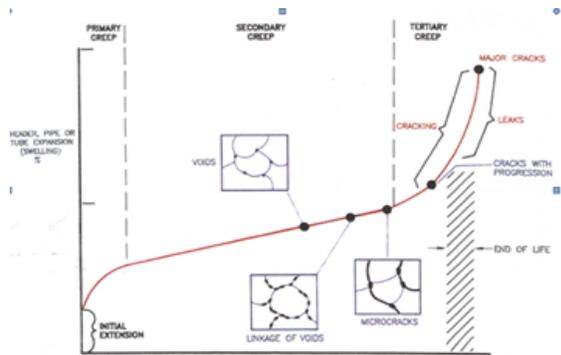
Figure 3. Stages of Creep Development. As creep stages progress, illustrated in the graphic above, the voids begin to link with one another, developing into cracks which then propagate through the material eventually causing leaks or failures.

In the next stage, the extension (or expansion) rates decreases with time. This stage is also called a transient or primary creep stage. The primary creep stage is not considered to represent damage. Subsequently, a stage occurs on the creep

curve located where the rate of creep (expansion) is nearly constant. This stage is also called secondary creep. The period of secondary creep after some expansion (i.e., in the latter period of the stage) is evidenced by initial void formation along the grain boundaries. In time, these tend to join or "link up". Void formation generally tends to develop after approximately 50% of the life of the pipe material has been consumed. Thus, on the basis of the microstructures and the absence of any evidence of void formation, the high-energy Piping would be expected to be suitable for another 200,000 hours of service.

The fourth stage of the creep curve, located beyond the constant creep rate portion, involves a rapidly increasing creep rate. This stage is called tertiary creep. It involves grain boundary fissuring (or microcracking). After this stage is reached, the material would tend to develop failure. This may represent a "remaining-life" period of 5% to 10% of

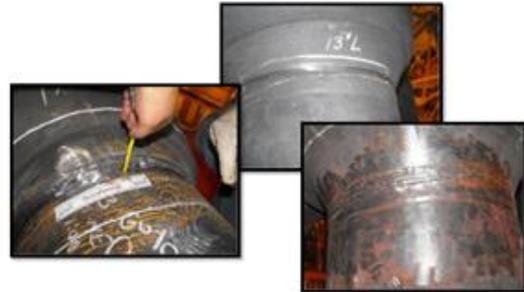
Figure 4. Images of the indication which required weld repair.

In April of 2010, Thielsch Engineering discovered two significant indications in the girth welds located on the legs of a wye block in the Main Steam piping system of a power station located in the Midwest.

The linear fatigue-type surface indications were discovered during the wet fluorescent magnetic particle examination. The first indication was 13"

long, at the 12:00 o'clock in the toe of the weld on the north wye block. The second indication was 4" long at the 12:00 o'clock position, in the toe of the weld on the same wye block. These indications were evaluated and confirmed to require repairs. Figure 4 below illustrates the indication location and repair.

Thielsch Engineering was contracted to provide guidance and supervision to supply a weld repair program, and to perform repairs by welding on the Main Steam piping system, thus returning the piping to a level of integrity suitable for continued service under design operating conditions. After conducting a thorough examination of the piping

system, it was revealed that several hangers upstream and downstream of this weld were either damaged or bottomed out resulting in insufficient piping support and movement. A full hot and cold condition hanger walkdown and pipe stress analyses were recommended to bring the unit back to a suitable condition for continued safe and reliable operation.

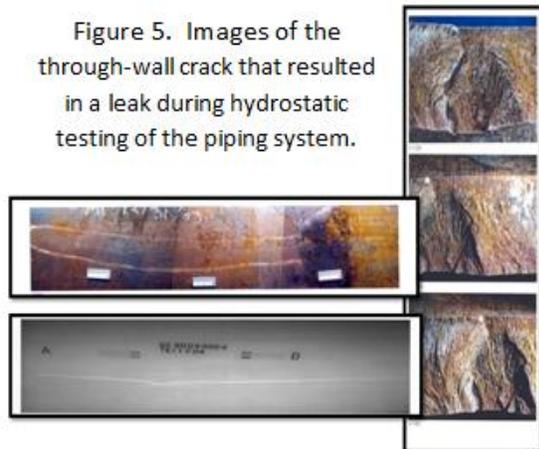
The design, fabrication and erection of the Hot Reheat piping system were reported to have been performed in accordance with the requirements of the ASME B31.1 Code on Pressure Piping covering "Power Piping". The design of this piping system was completed by Sargent & Lundy of Chicago, Illinois. The design conditions involved a pressure of 650 psig at a temperature of 1050°F. Sargent & Lundy elected to use alloy steel pipe and fittings. The pipe was produced in accordance with the requirements of ASTM Specification A-335, Grade P91 covering "Seamless Ferritic Alloy-Steel Pipe for High-Temperature Service". (For reference purposes, Grade P91 is a modified 9 Cr - 1 Mo alloy steel material.) Figure 5 below displays images of the through-wall crack in the P91 material.

The results of the metallurgical evaluation confirmed that the pipe segment had been subject to localized overheating. The localized overheating was sufficiently severe to result in re-austenitization, grain growth and cracking. The cracking and microstructural transformations introduced during the localized overheating rendered the pipe subject to brittle failure during subsequent handling.

In January of 2004, General Electric Power Systems (GE) submitted a pipe segment to Thielsch Engineering. This pipe segment had been removed from a Hot Reheat piping system from a facility in Pennsylvania. It contained a through-wall crack that resulted in a leak during hydrostatic testing of the piping system. Thielsch Engineering was requested to perform a detailed metallurgical evaluation of the pipe segment to determine the cause of the crack.

The defect present in this pipe segment represents a localized condition. On the opposite side of the pipe segment, the microstructure and tensile properties were typical for pipe produced in accordance with ASTM Specification A-335, Grade P91. The source of the localized overheating could not be identified definitively from the results of the metallurgical evaluation. It is known, however, that the overheating occurred prior to the radiographic examination and postweld heat treatment of the affected field weld. Possible sources of localized overheating include the tempering heat treatment performed during original manufacture of the pipe, postweld heat treatment performed during fabrication of the spool piece of which this pipe was part, or some undocumented event.

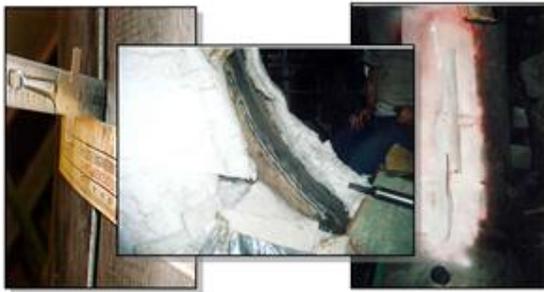
Figure 6. Images of the through-wall crack which required weld repair.

In May of 2002, a leak occurred in a Main Steam piping system at a facility located in the Midwest. This leak was the result of through-wall cracking that developed in the intrados of a clamshell elbow. Thielsch Engineering performed a metallurgical evaluation of two boat samples removed from this elbow to determine the cause of the cracking. The results of this metallurgical evaluation confirmed that the cracking in these boat samples was caused by fatigue acting in conjunction with creep. The cracking is the result of an applied bending stress. (The condition of the elbow, which had been welded with a low carbon filler material, contained at least one original weld defect, and had been heavily ground subsequent to welding, rendered it susceptible to failure by fatigue and/or creep.)

The Main Steam piping system was erected using low-alloy steel pipe and fittings. The pipe was produced to the requirements of ASTM Specification A-335 covering "Seamless Ferritic Alloy Steel Pipe for High-Temperature Service". It involved Grade P22, a low-alloy steel material with a nominal composition of 2-1/4% chromium and 1% molybdenum, i.e., a 2-1/4 Cr- 1 Mo low-alloy steel. The fittings were produced to the requirements of ASTM Specification A-217, Grade WC9 covering "Alloy Steel Castings for Pressure-Containing Parts Suitable for High-Temperature Service". Figure 6 illustrates the through-wall crack and repair process.

Thielsch Engineering developed and instituted a repair welding program to address the

cracking that had developed in the intrados of the elbow. This program, which complied with the requirements of all applicable Codes, has restored the replacement elbow to a level of integrity suitable for continued service for at least five additional years.
